MODEL
XF

NUMBER
JTB00159
(Issue 1)

TECHNICAL BULLETIN

Roof Console Lights that do not Operate as Expected - Repair Procedure

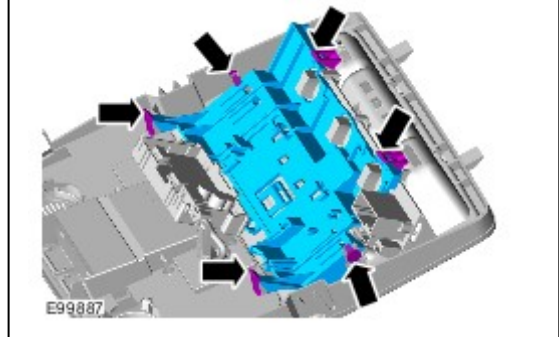
Figure 1

Situation: The roof / overhead console lights may not operate as expected. This may be caused by oxidization of the electrical contacts within the roof console.

1. Refer to Workshop Manual (GTR) section 501-12: Instrument Panel and Console and remove the roof / overhead console.
2. Release connection for microphone.
3. Remove the retaining cover. (Figure 1)
 - Release the six clips.
