Climate Control - Passenger Side Register

Removal and Installation

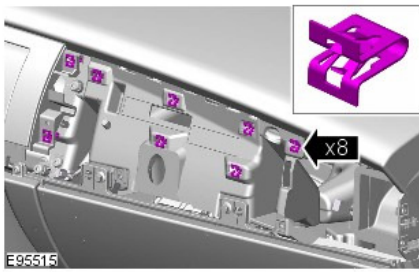
6. Install the clips into the instrument panel.

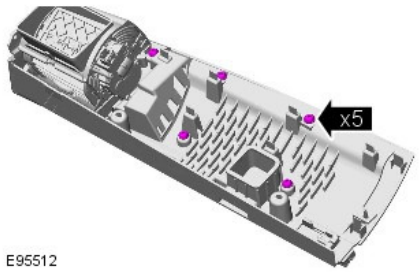
7. NOTE: Do not disassemble further if the component is removed for access only.

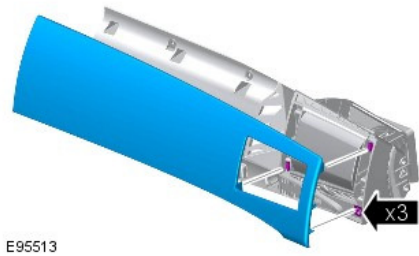
8. NOTE: When removing the component, some of the clips may remain attached. These clips should be removed and returned to their original positions in the passenger side register carrier.
